Ceramic Applications in Turbine Engines

Harold E. Helms, Peter W. Heitman,
Leonard C. Lindgren, and Samuel R. Thrasher
Allison Gas Turbine Division
General Motors Corporation

October 1984

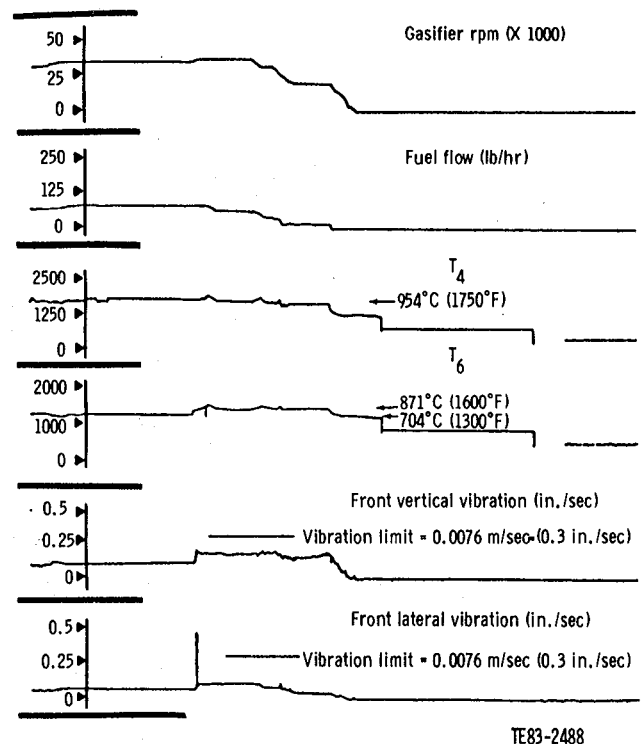
Data recorded during Test 2 are shown in Figure 15. Note the front lateral vibration spike and the low level of vibration that continued until shutdown. With all the other recorded parameters shown by the strip chart within limits, the loss in CDP and high negative torque was the only indication of a problem with the engine. Shutdown was initiated and the engine borescoped. Inspection revealed that a failure did occur in the gasifier turbine. The engine was left on the test stand while a failure investigation plan was formulated.

Figure 15. Strip chart data at time of failure for engine C-4, BU13.

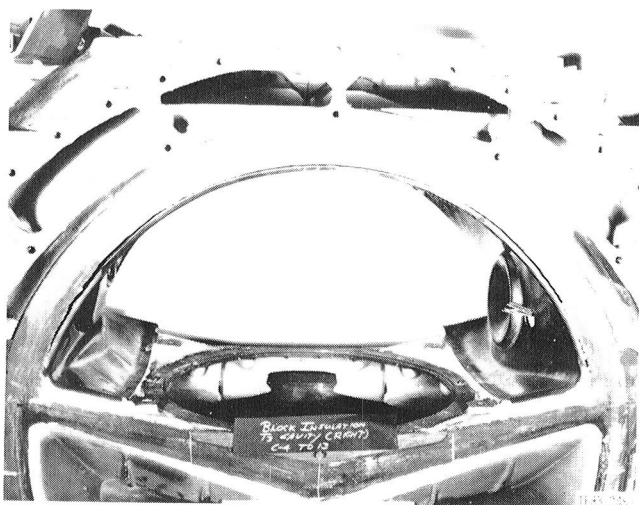
Figure 16. Fiberfrax insulation missing (T_3 cavity).

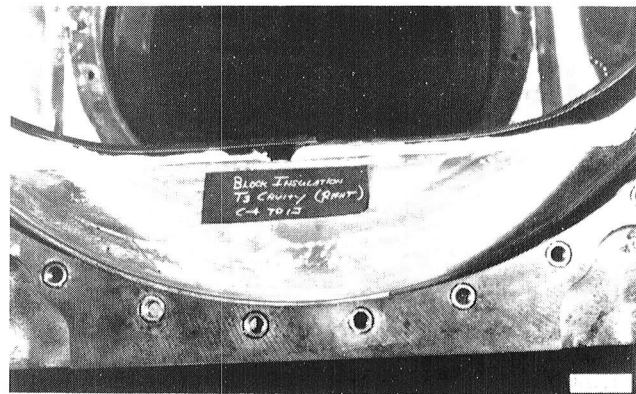
Figure 17. T_3 cavity area where Fiberfrax insulation could have entered.

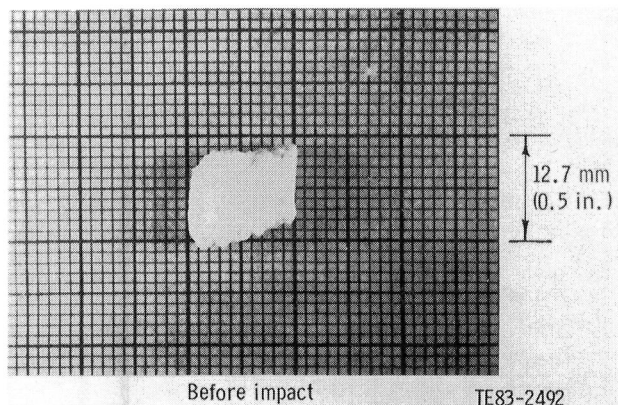
weighing 0.715 g and illustrated in Figure 20. (This size will pass the combustor air dilution holes and the gasifier nozzle vane throat.) The bulk of the sample survived the impact test, as shown in Figure 21. The remnant weighed 0.57 g or 80% of the weight before impact. The insulation was positioned to strike the blade approximately 6 mm (0.24 in.) below the airfoil tip. This piece failed the airfoil near the root similar to the engine failure blades. The failed blade is shown in Figures 22 and 23. The laboratory identified the failure origin at the suction side

Figure 20. Fiberfrax FOD particle before impact, turbine blade test No. 1.

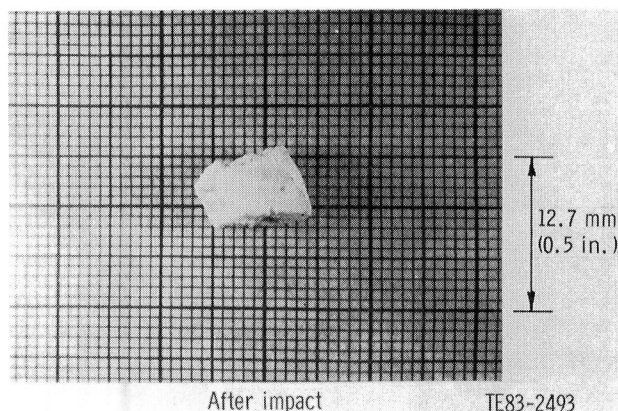
Figure 21. Fiberfrax FOD particle after impact, turbine blade test No. 1.

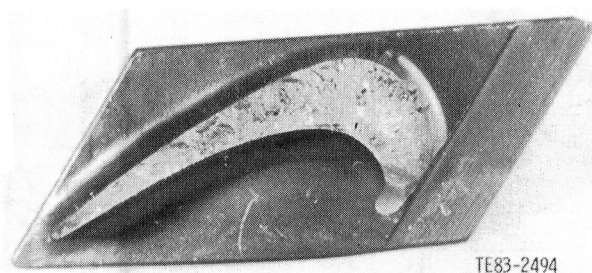
Figure 22. Failed spin test blade, Fiberfrax FOD test (top view).

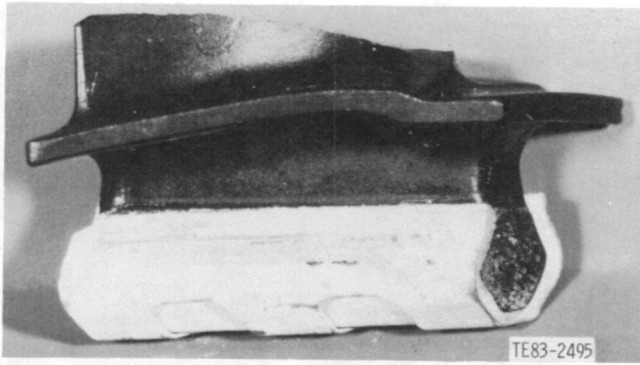
Figure 23. Failed spin test blade, Fiberfrax FOD test (side view).

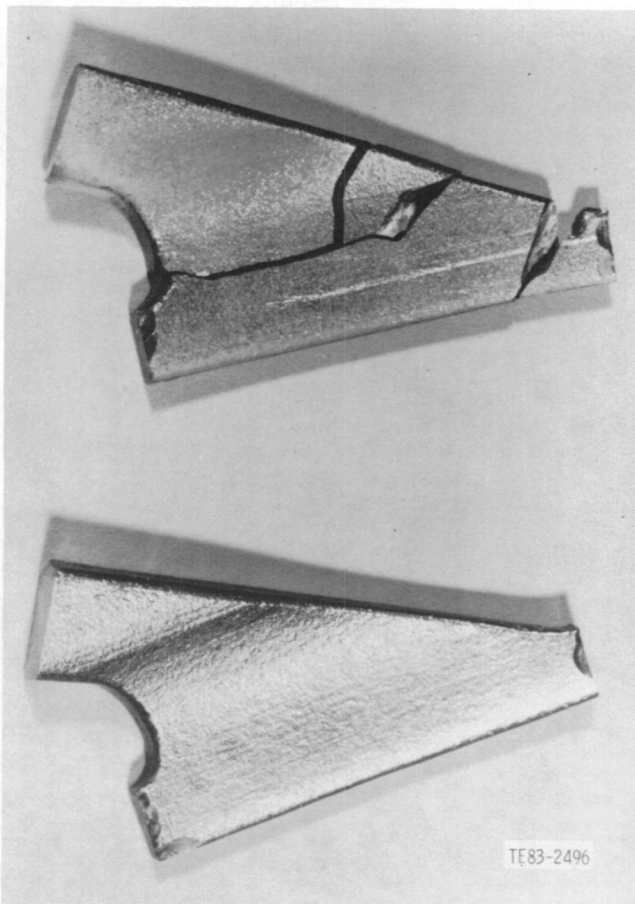
test. Figure 24 shows the segment before impact and after impact, when the segment broke into multiple pieces. Again, this size particle will pass the nozzle vane throat. The segment was positioned to strike the blade approximately 6 mm (0.24 in.) below the airfoil tip. In the high-speed film, two

Figure 24. Outer vane support ring FOD segment before and after impact, turbine blade Test No. 2.

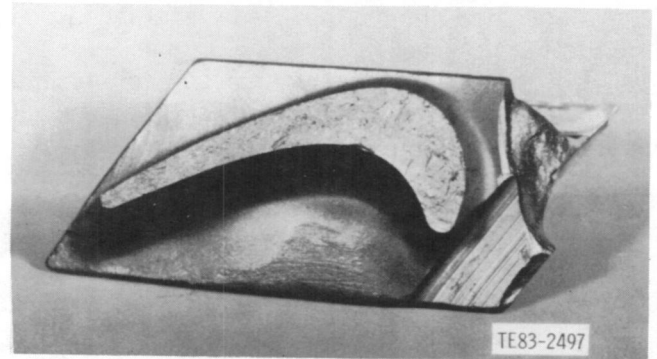
impacts of the outer vane support ring (OVSR) segment are evident. This piece failed the airfoil (completely obliterated) near the root similar to the engine failure blades. Furthermore, the forward acute corner of the platform was also failed similar to 12 engine blades. This is shown in Figures 25 and 26. Laboratory analysis identified the origin of the platform corner failure to be in the stalk, as was the case with the engine blades.

Figure 25. Failed spin test blade, OVSR segment FOD test (top view).

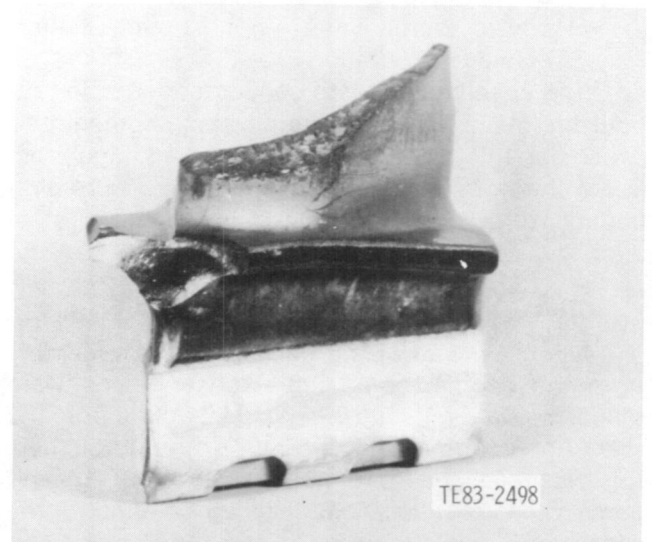
Figure 26. Failed spin test blade, OVSR segment FOD test (side view).

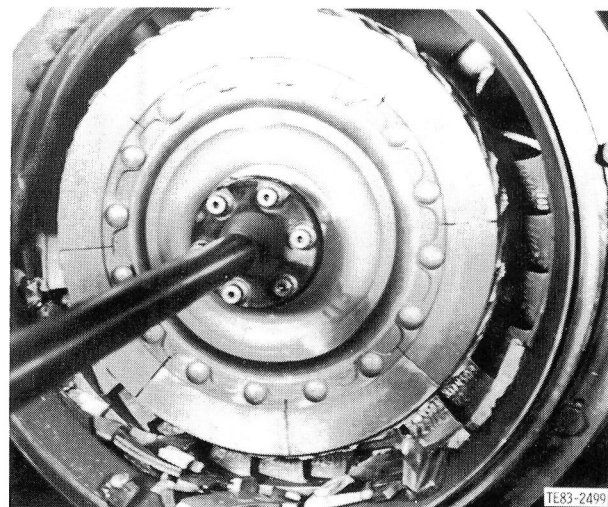
Upon removal of the gasifier nozzle assembly from the engine, some initial observations were made. (Figure 27 shows the gasifier section from the rear.) Approximately the top half of the nozzle section was missing. There are pieces of the rings and some vanes resting at the 180-deg position. Some vanes were cracked but still remained in place.

Figure 27. Gasifier turbine assembly.

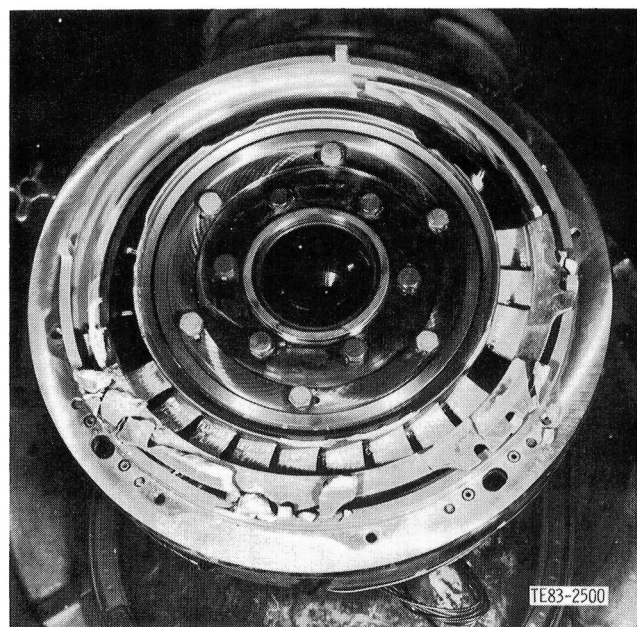
ditional pieces have fallen out of place during handling, but the retaining ring was continuous through about a 260-deg arc. The portion of the outer vane support ring that remained in place was cracked in four places through a 180-deg arc. Twelve vanes remained firmly in place, three fewer than were seen in Figure 27. The inner vane support ring was in one piece with large chips removed from the trailing edge. As was mentioned earlier, very few pieces of the shroud remained in place.

Figure 28. Gasifier nozzle after removal of rotor of engine C-4, TD14.

The condition of the gasifier and power turbine rotor at engine teardown is illustrated in Figures 28, 29, 42, and 43. Figure 28 is a view of the outlet (exit) side of the gasifier turbine rotor with the rotor still installed in the mount pedestal. Considerable upstream ceramic component debris accumulated at the 6 o'clock position. No blade remnants could be identified. However, the most significant observation was the release of all airfoils at the root attachment just above the platform; there were no dovetail attachment or stalk region failures as typically observed in proof spin tests. This is not completely evident in Figure 29 although it was readily observed at teardown. Additional photos that illustrate this observation will be presented as part of the failure in-

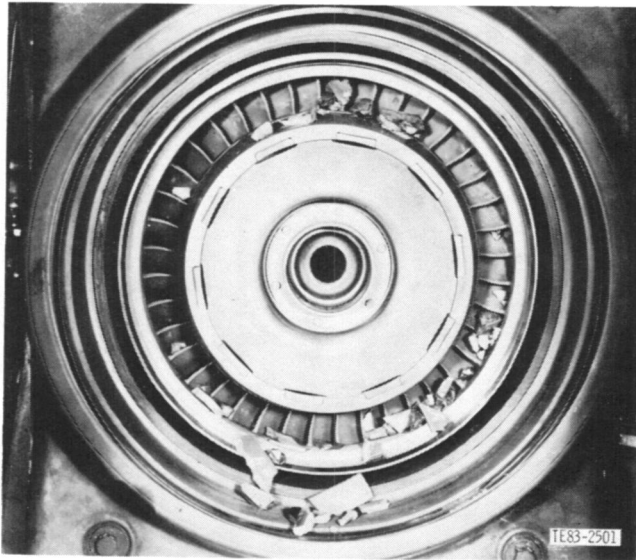
Figure 29. Power turbine nozzle assembly.

Figure 29 is a view into the inlet of the power turbine nozzle. This shows large pieces of the retaining ring and outer vane support ring, some pieces of the shroud, and a few pieces of vanes lodged against the power turbine nozzle. Some pieces are wedged between the vanes while most of the pieces are loose. The size of the pieces remaining indicated that the gasifier turbine blades were already

Figure 29 is a view of the inlet side of the power turbine nozzle. Sizable pieces of upstream ceramic debris were identified as shroud and vane outer support ring pieces. These could not have passed through the turbine blades.

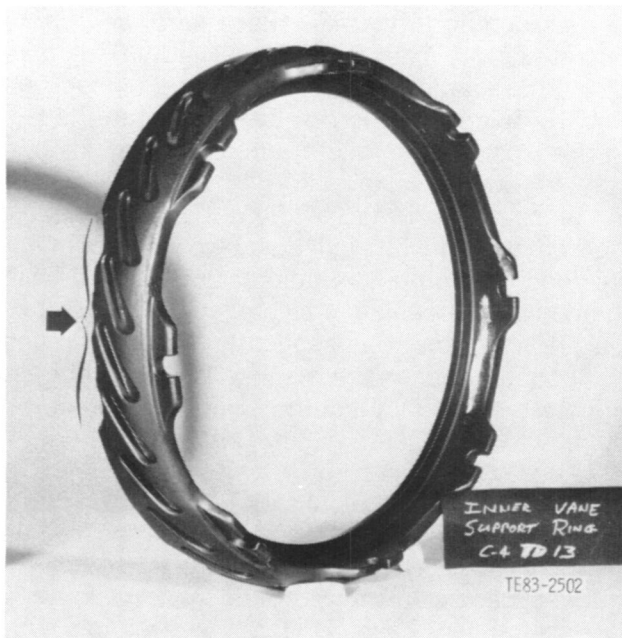
Figure 30. Inner vane support ring after disassembly of engine C-4 (aft view).

Figures 30 and 31 show the inner vane support ring after removal from the assembly. The ring is not cracked through but has six areas of large chips at the trailing edge. Closer examination by the Materials Laboratory revealed that the inner vane support ring was primarily intact, with some minor damage on the lip at six locations. The area of the inner ring that was chipped was the back lip adjacent to vane pockets 3, 4, 7-10, 15, 20, and 26. All of these chips originated from the inside diameter of the ring near the vane pockets. A typical example of the damage is shown in Figure 32, pocket 20. Pocket 28 was also observed to be chipped at the forward section of the vane pocket. The damage to the inner ring is believed to have been caused by impact with platforms of the blades.

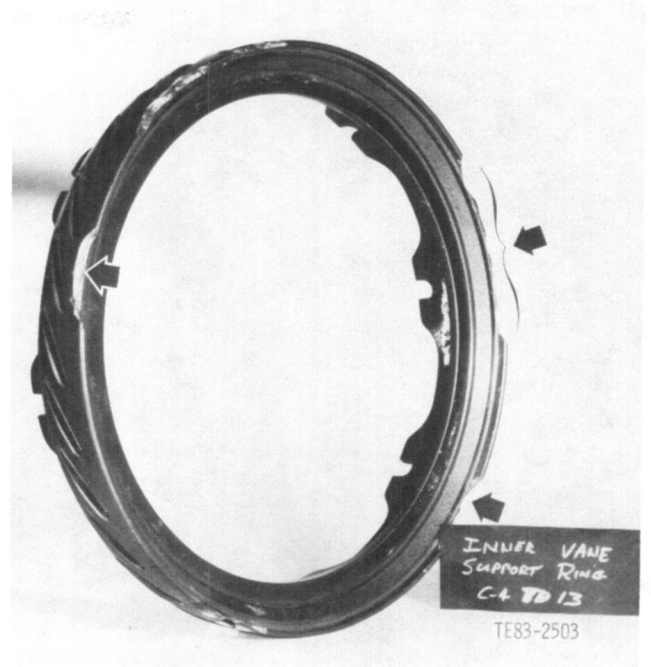
Figure 31. Inner vane support ring after disassembly of engine C-4 (forward view).

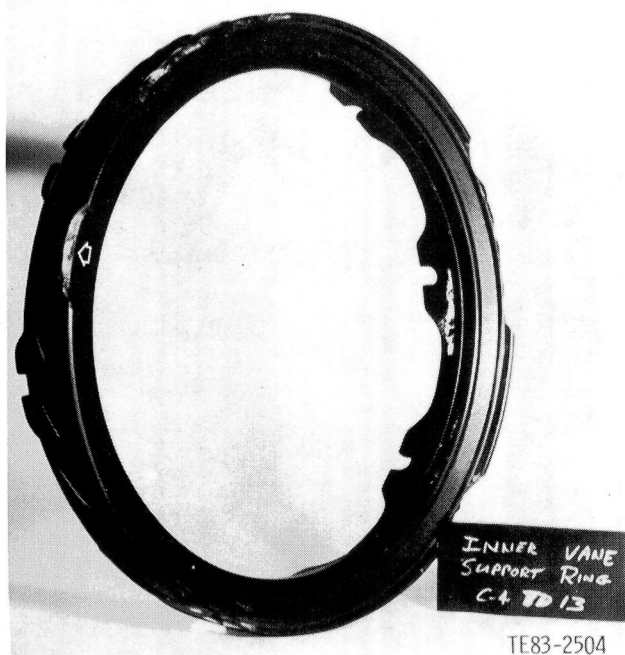
Figure 32. Inner vane support ring fracture origin caused by impact.

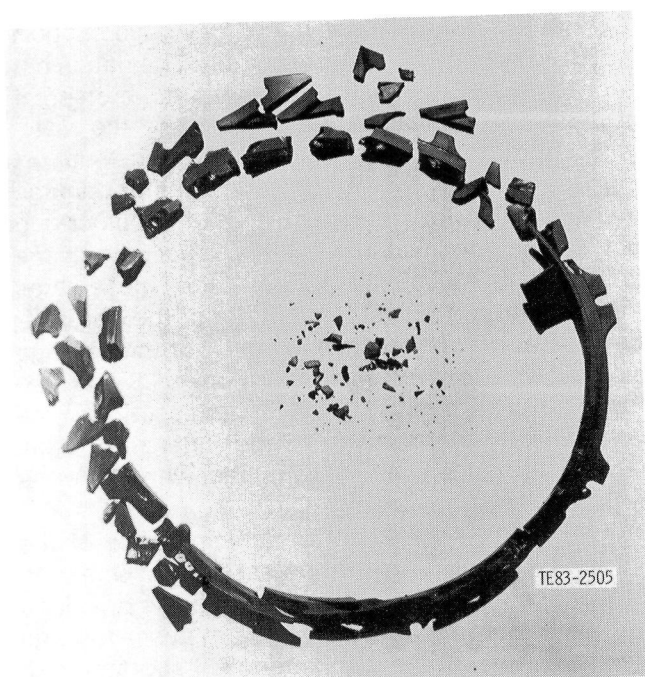
Figure 33 shows the remaining pieces of the outer vane support ring after disassembly. One vane was wedged in place with small particles of silicon carbide between the vane slot and the vane foot. All pieces were sent to the Materials Laboratory for closer evaluation.

Figure 33. Remaining pieces of outer vane support ring after disassembly of engine C-4.

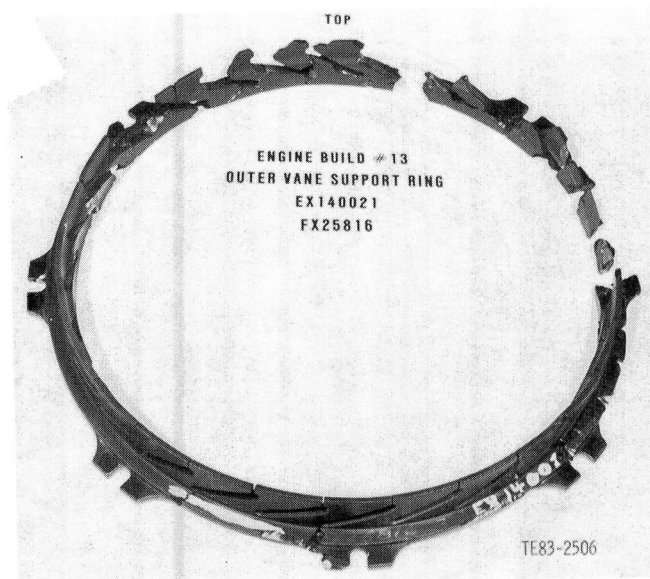
broken in several places. In addition, pieces from pockets 26 to 2 and 3 to 6 were recovered. The partially reconstructed ring is shown in Figure 34. The

Figure 34. Outer vane support ring after reconstruction by Materials Laboratory.

majority of fractures in this component were contact or impact failures that initiated from the aft portion of the vane pocket surface. A typical example of this contact fracture is shown in Figure 35. Several pieces of the ring were fractured from the aft portion of the flange, inside diameter (see lug chart in Figure 36).

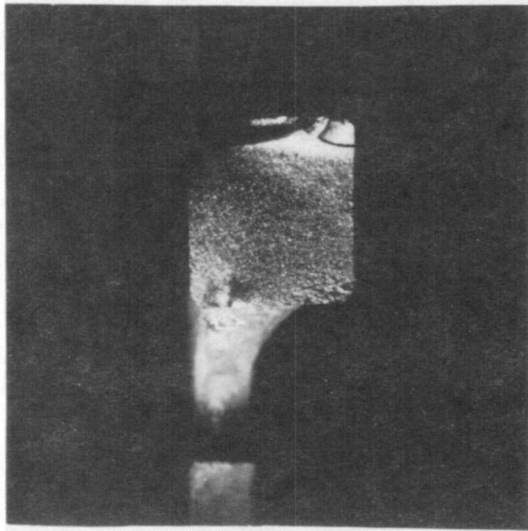
Figure 35. Outer vane support ring contact fracture.

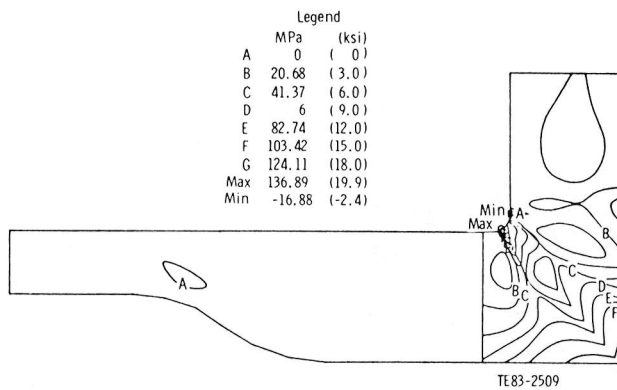
Figure 38. Plot of maximum principal stress at 12 sec into deceleration for support ring with slots at leading edge of each vane pocket.

pocket inside diameter is approximately 62.0 MPa (9.0 ksi). This 2-D analysis does not account for a stress concentration factor in that area. With no slots at the leading edge, the maximum principal stress was reduced to 125.7 MPa (18.2 ksi) with a P_s of 0.99535 for the same conditions. Figure 39 shows that the pocket stress increased to 96.5 MPa (14.0 ksi) even though the maximum principal stress decreased. The P_s stated for these cases assumes $\sigma_{os} = 774.1$ MPa (50.0 ksi), $\sigma_{ov} = 626.3$ MPa (27.0 ksi), and Weibull modulus = 8. Even with a stress concentration, the predicted pocket stresses would not cause failure in an unslotted ring. Therefore, to reduce the possibility of an outer vane support ring failure, the next ring to be engine tested was unslotted.

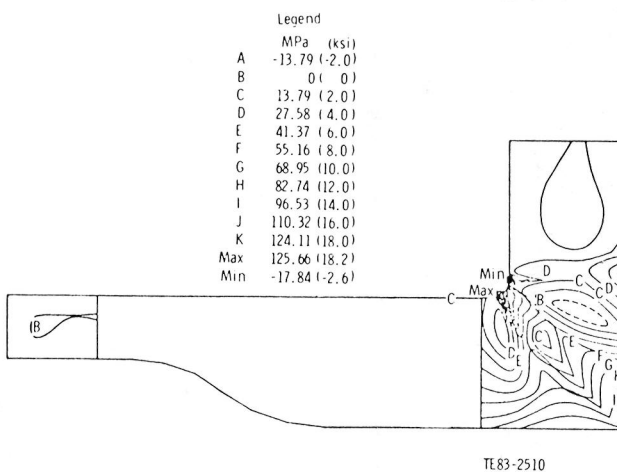
Figure 39. Plot of maximum principal stress at 12 sec into deceleration for outer vane support ring with no slots at leading edge of vane pockets.

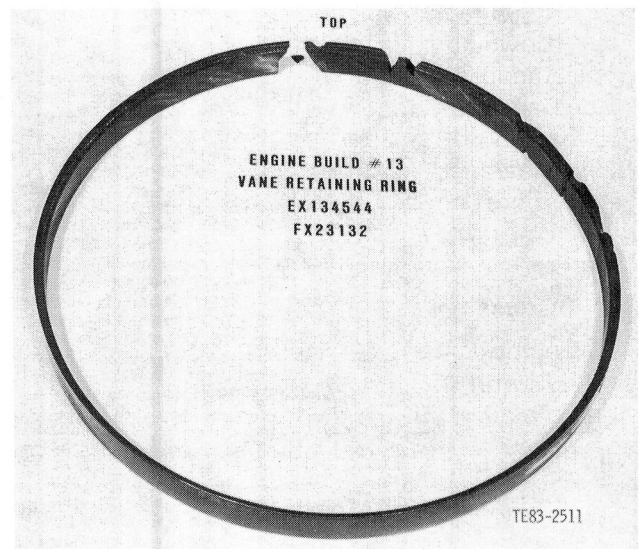
The vane retaining ring was approximately 75% intact. Figure 40 shows that most of the pieces of the ring were found and were able to be placed back in position. Materials Laboratory evaluation found the vane retaining ring fractured in 11 places located over about 30% of the circumference, which coincided with the area of maximum damage to the outer vane support ring. With the exception of one piece, which showed a typical tensile failure, all of the fractures in this ring were secondary fractures resulting from impact damage, primarily at the aft portion of the ring.

Figure 40. Vane retaining ring after reconstruction by Materials Laboratory.

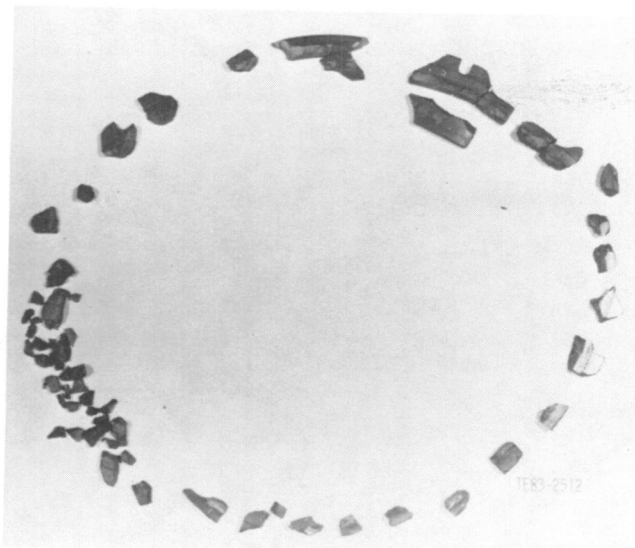
Figure 41 shows the few remaining pieces of the shroud ring. Most of the pieces are part of the flange that was trapped between the outer vane sup-

Figure 41. Remaining piece of shroud ring after disassembly of engine C-4, TD13.

Although insufficient pieces of the shroud remained to perform a meaningful evaluation, a few fragments of the abrasible layer appeared to have been blasted by debris. No obvious cause of failure could be determined from the pieces remaining. The radial clearance between the shroud and the blade tip was an average of 1.12 mm (0.044 in.) cold and a calculated average of 0.889 mm (0.035 in.) hot. The calculated minimum hot radial clearance was 0.559 mm (0.022 in.). Previous test experience with metal blades and a ceramic shroud indicated that with an average hot radial clearance of 0.419 mm (0.0165 in.) the rotor would just rub the shroud. Therefore, with the ceramic blades growing less than the metal blades and with a larger clearance, it was thought that no rub was possible. This same magnitude of radial clearance was measured between the inner vane support ring lip and the blade platform, and no evidence of rub was visible.

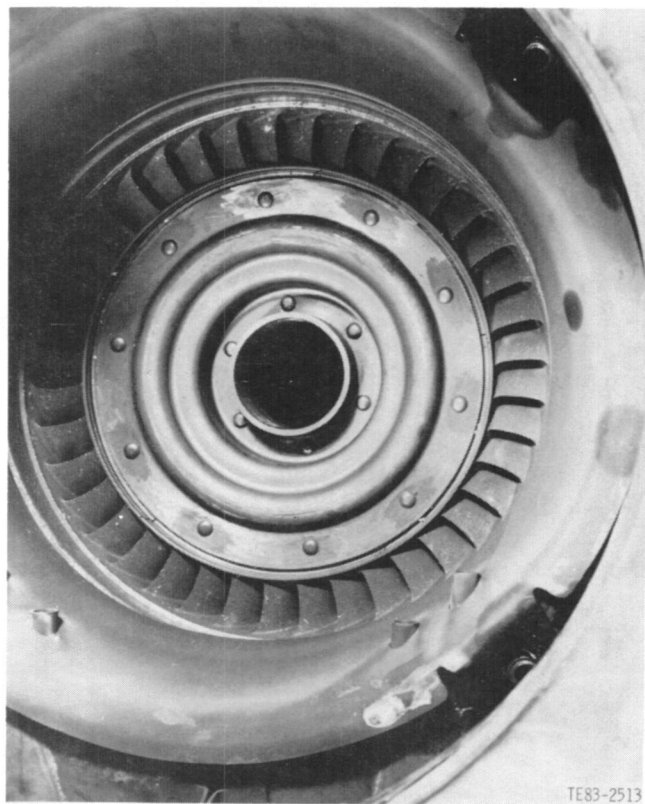
Figure 42. Power turbine nozzle assembly, outlet side, engine C-4, TD13.

Figure 42 is a view of the outlet side of the power turbine nozzle. General abrasion by the SiC debris is evident, particularly in the blade tip track. In this photograph, some evidence of labyrinth seal rub is evident at the inside diameter. However, substantial local rub was observed at the 6 o'clock position.

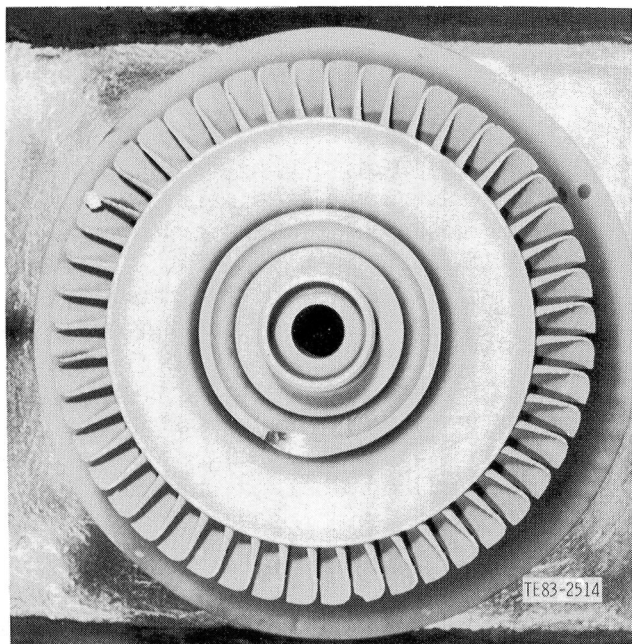
Figure 43. Power turbine, engine C-4, TD13.

Figure 43 is a view of the inlet side of the power turbine rotor. Extensive abrasion of the blades is evident, and one piece of ceramic debris is trapped between blades. Visual inspection of the rotor revealed bright (polished) rotoring labyrinth seals compatible with the rub evidence on the corresponding stationary seal member in the power turbine nozzle. No other distress was noted. This completed the teardown observations relative to the turbines.

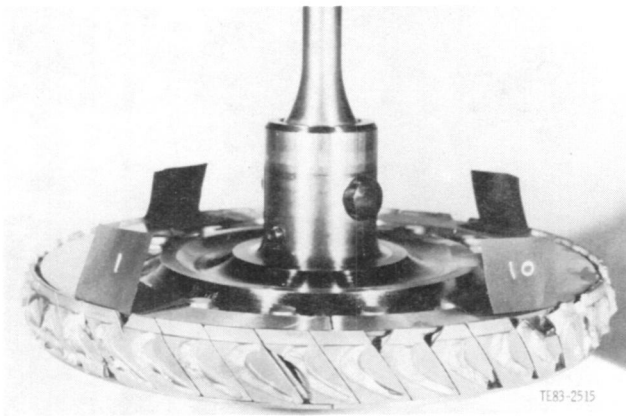
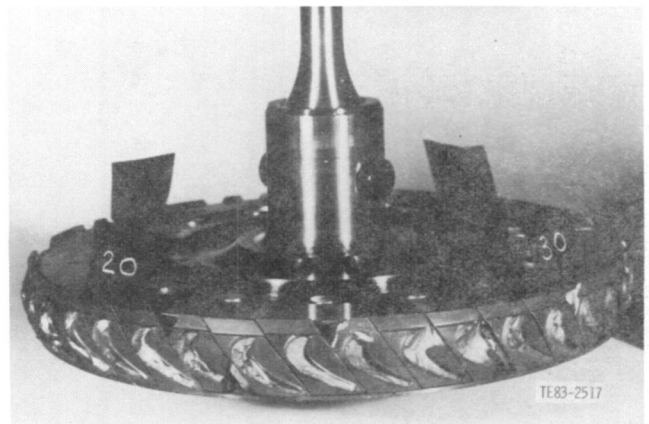
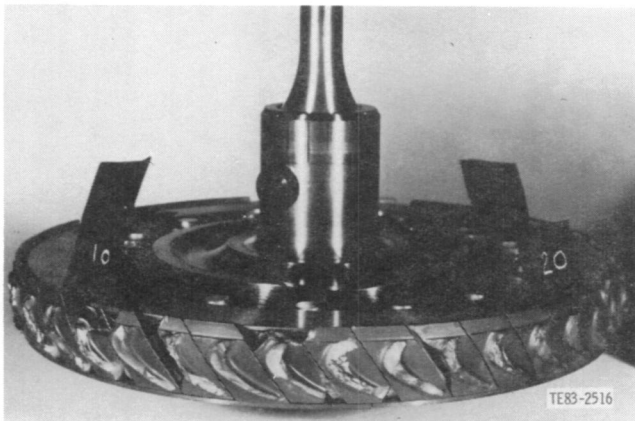
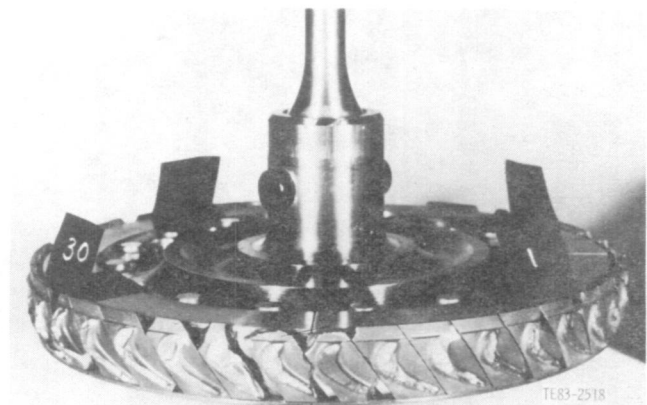
In support of the investigation, the failed blades were subjected to detailed laboratory analysis for definition of the failure nature and origin. Shown in Figures 45 through 48 are close-up views of the failed blades. The release of all airfoils at the root attachment (noted earlier) is evident. An interesting feature is the forward corner failure of the lip seal (platform) on multiple blades. No evidence of contact (rub) of the platform lip seal with the vane inner support ring is seen. The cover plates were removed and the blades withdrawn from the wheel. No bending was noted, and the contact (bedding) pattern on the compliant layer was uniform for every layer. This was consistent with no attachment failures.

Laboratory investigation noted that the airfoils of each of the gasifier blades were lost just above the platform. Analysis of the fracture surfaces indicated that all fractures originated as a result of impact damage at the leading edge of the airfoil and then propagated in several different modes. One failure mode involved the crack front shearing through the entire airfoil with no distortion, as shown in Figure 49. The other modes featured cracks propagating from the crown (near the leading edge) along the suction side of the airfoil, as shown in Figure 50, or along the pressure side, as shown in Figure 51. Several of the blades had double fracture origins, with the primary origin at the suction side of the airfoil near the leading edge (crown) and the secondary origin located on the suction side of the airfoil nearer the trailing edge, as shown in Figure 52. Several blades had more complicated multiple fractures, not

Figure 45. Gasifier turbine rotor C-4, TD13, blades No. 1 through 10 of 40 total.

Figure 47. Gasifier turbine rotor C-4, TD13, blades No. 20 through 30 of 40 total.

Figure 46. Gasifier turbine rotor C-4, TD13, blades No. 10 through 20 of 40 total.

Figure 48. Gasifier turbine rotor C-4, TD13, blades No. 30 through 40 of 40 total.

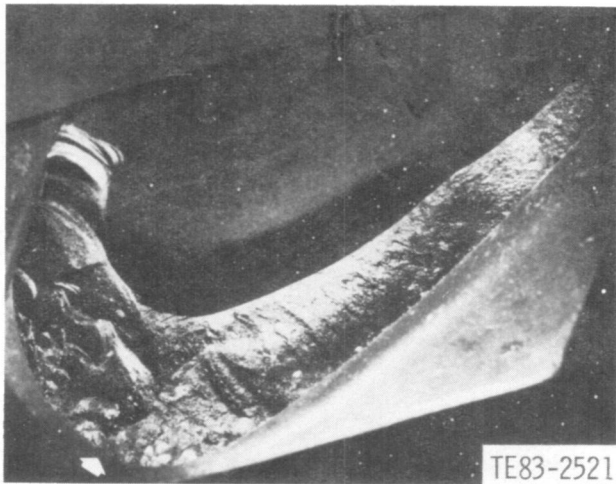
Figure 51. Blade fracture propagating along pressure side of airfoil.

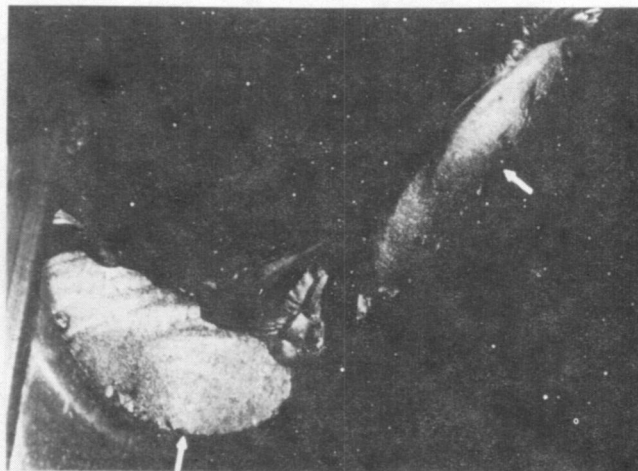
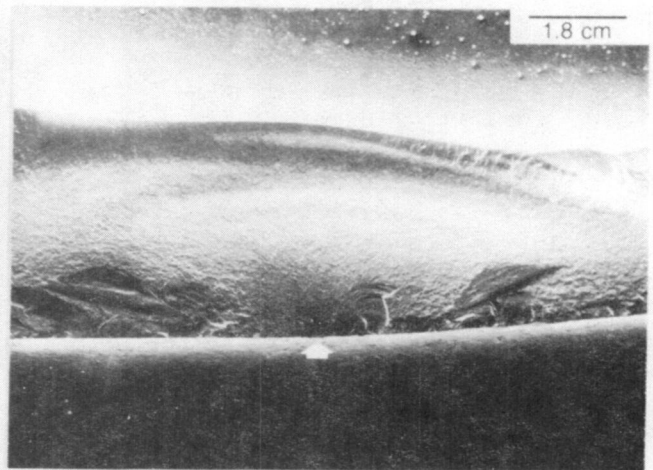
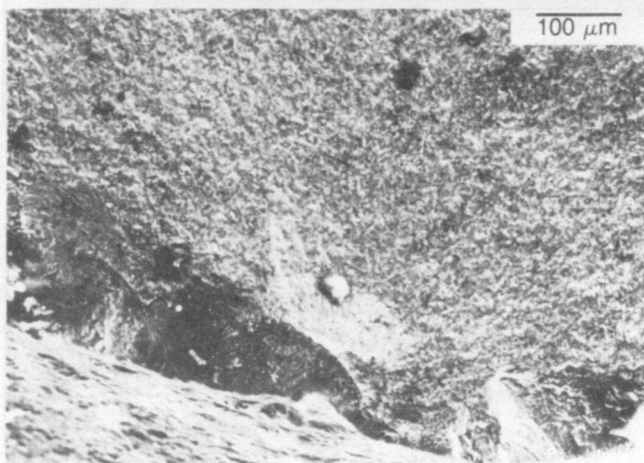
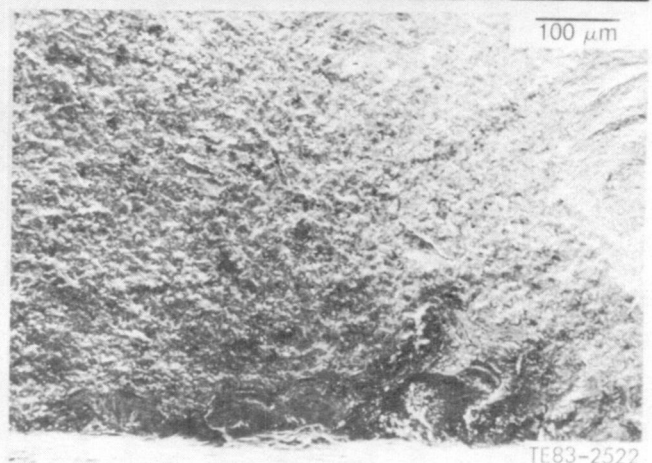
Figure 52. Blade fracture with double fracture origins.

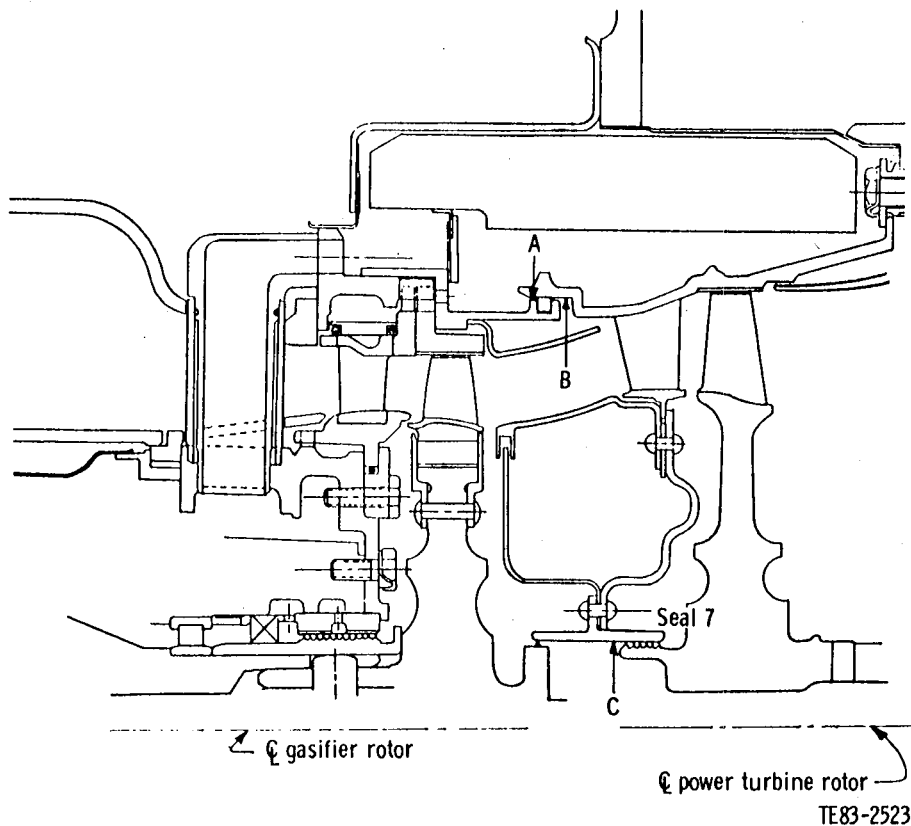
The diameter and runout relative to the centerline of the gasifier turbine at locations A, B, and C per Figure 53 were taken. These served to define the radial engagement of the gasifier nozzle into the power turbine nozzle. The results are shown in Figure 54. Note that the center of the power turbine nozzle is displaced 0.46 mm (0.018 in.) from the center of the gasifier nozzle. The piston ring seal accommodates this with no line-to-line contact. This offset also suggests seal 7 (see Figure 53) would interfere at assembly as shown in Figure 55 and prevent rotation of the power turbine. However, the power turbine spun freely at assembly, and this observation led to step 2 in the measurement investigation.

Figure 53. Measurement locations for checking engine block distortion.

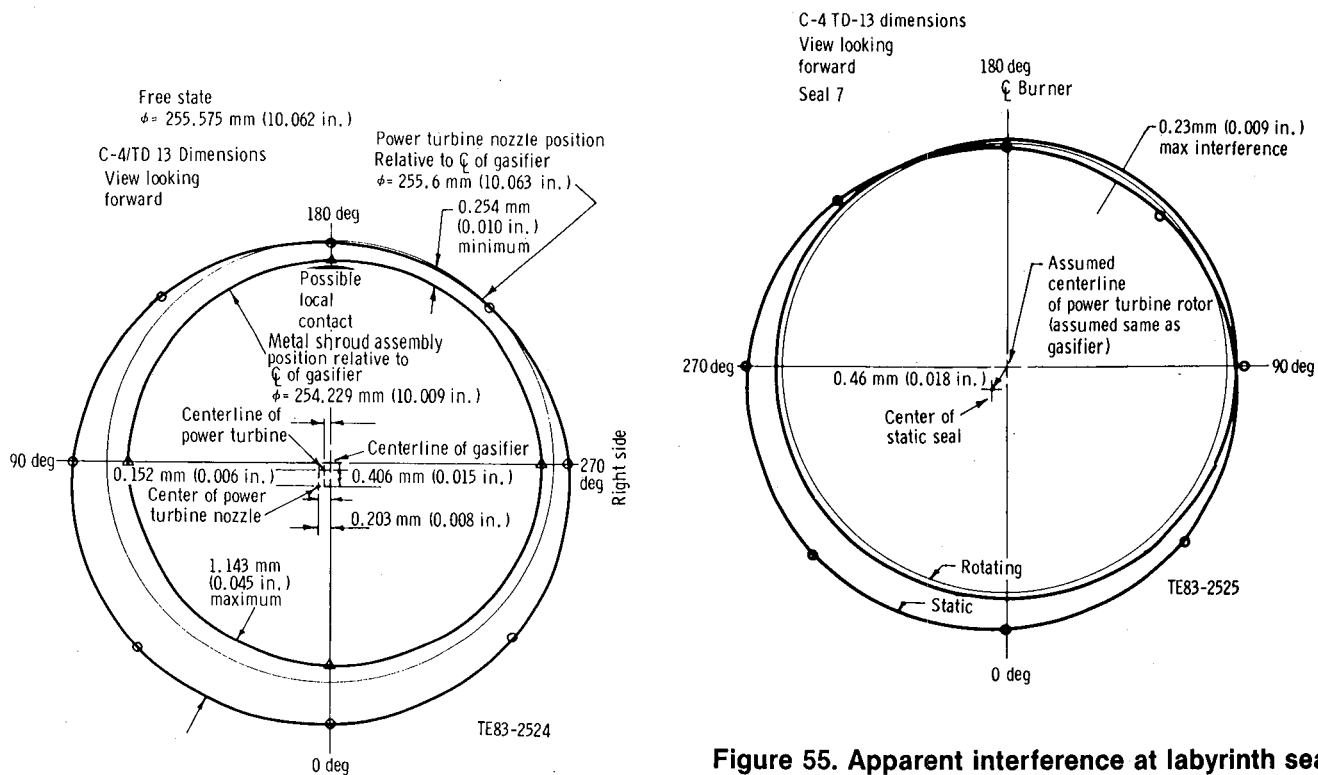
Figure 54. Engagement of the gasifier nozzle into the power turbine nozzle.

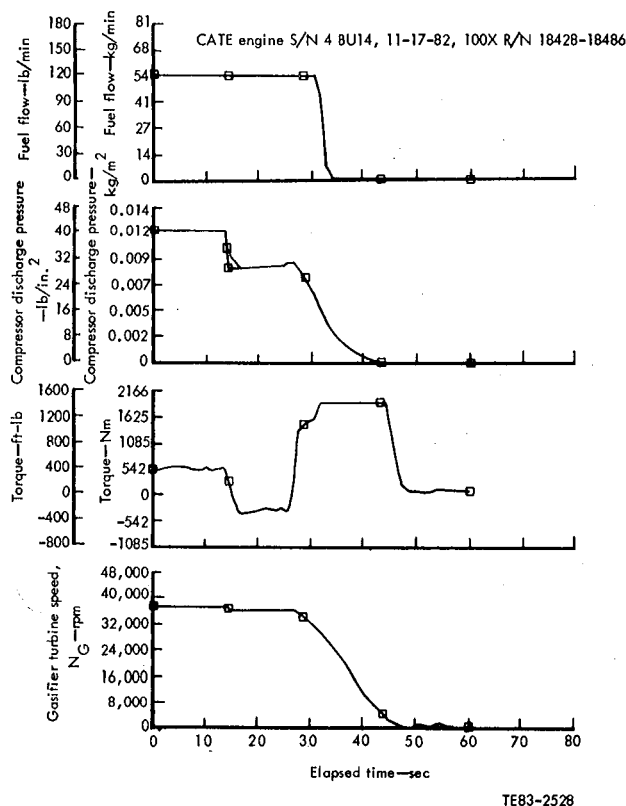
Data recorded during the test are shown in Figures 58 and 59. The front lateral vibration spike at the time of failure indicates a time lapse of 17 sec

Figure 58. Data recorded at time of failure—engine C-4, BU14.

before auto shutdown due to T_6 (power turbine exit) overtemperature. Other parameters that indicated failure were loss of compressor discharge pressure, high negative torque, and high T_4 . Inspection revealed that a failure did occur in the gasifier turbine. The engine was moved to the assembly floor and a failure investigation was conducted.

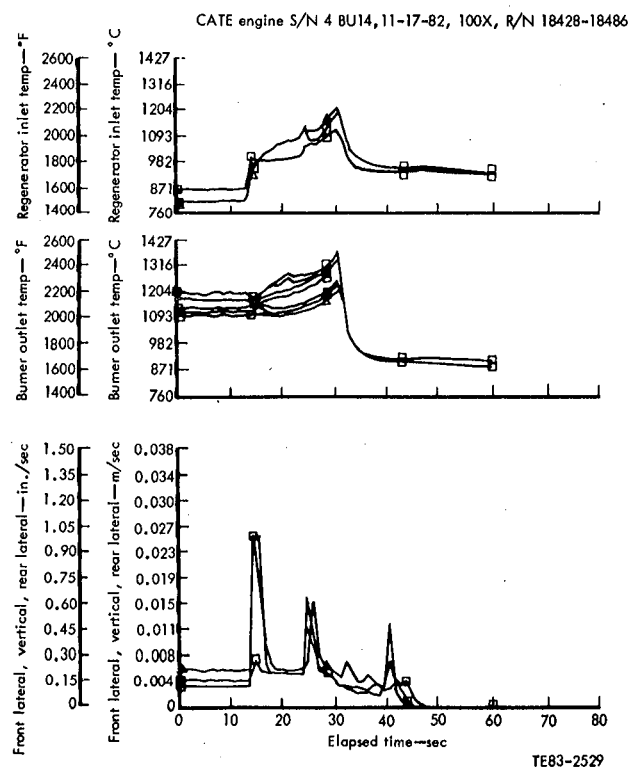
Figure 59. Data recorded at time of failure—engine C-4, BU14.

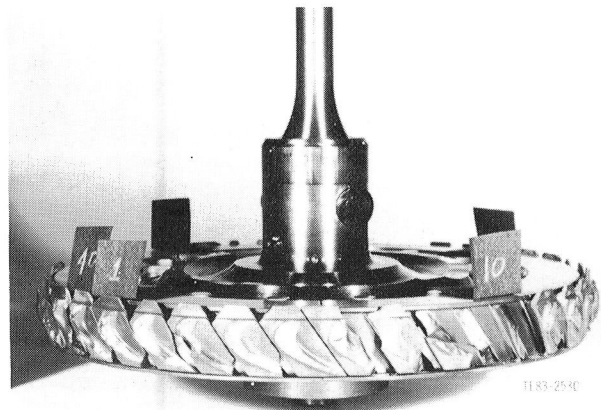
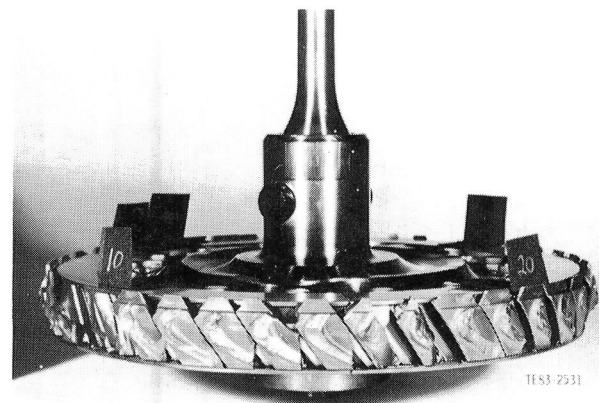
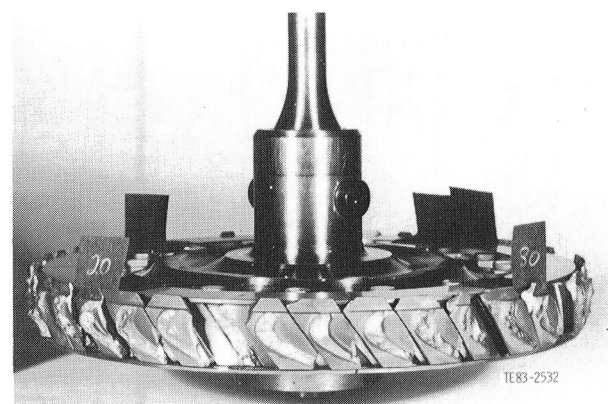
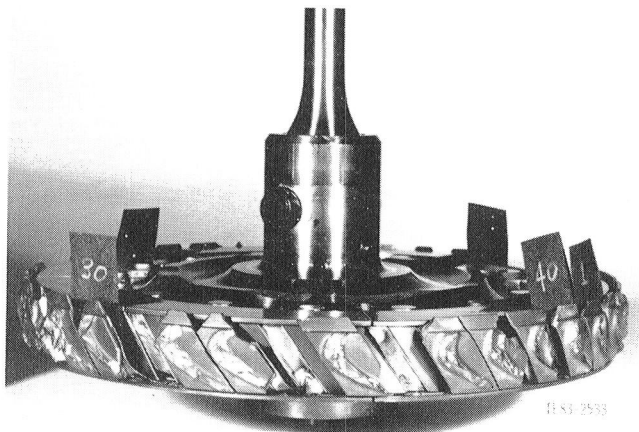
The condition of the gasifier rotor at engine teardown is illustrated in Figures 60, 61, 62, and 63.

The six blades failed below the platform are No. 9, 10, 23, 31, 34, and 36. The failure surface is typically very ragged, except for No. 31. The blade remnants were easily removed from the wheel and the compliant layer contact pattern was uniform for every blade.

Figure 60. Gasifier turbine rotor C-4, TD14, blades No. 1 through 10 of 40 total.

Figure 61. Gasifier turbine rotor C-4, TD14, blades No. 10 through 20 of 40 total.

Figure 62. Gasifier turbine rotor C-4, TD14, blades No. 20 through 30 of 40 total.

Figure 63. Gasifier turbine rotor C-4, TD14, blades No. 30 through 40 of 40 total.

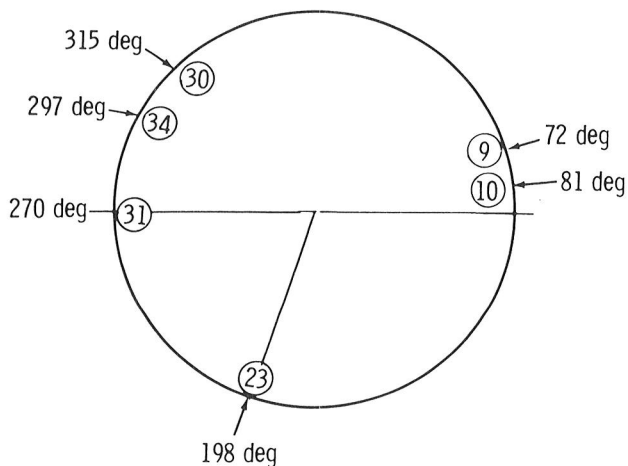
Figure 64. Clocking the position of failed gasifier turbine blades, engine C-4, TD14.

Clocking of the attachment failure blades suggested a pattern of failure at 120-deg intervals, as shown in Figure 64. However, a condition of blades selectively vibrating (such as at every 120 deg) has

Failed blades—after approximately 2 hr and 39 min steady state

1. Never-observed blades selectively vibrating (as every 120 deg) in any DDA turbine or compressor.
2. CATE wheel
All frequencies well in excess of operating range

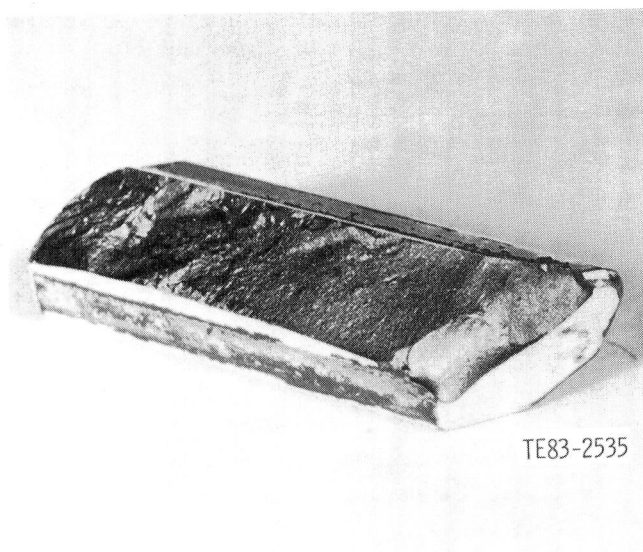
Figure 65. Blade No. 31, attachment remnant, engine C-4, TD14.

A description of the laboratory investigation and results follows. The interesting attachment failure was identified as No. 31. The other failures were impact type ragged fracture surfaces. Figure 65 shows the attachment remnant and a sketch looking radially inward, and Figure 66 includes a magnified view of the failure surface. The features are the following:

Stress redistribution results from local changes in the contact (bedding) pattern. The measured compliant layer thinning is suspected to have triggered the flaw in blade No. 31 with subsequent blade release. Note in Table VIII, blade No. 31, that the layer area adjacent to the failure location was thinned, indicating eventual increase in load at location 6.

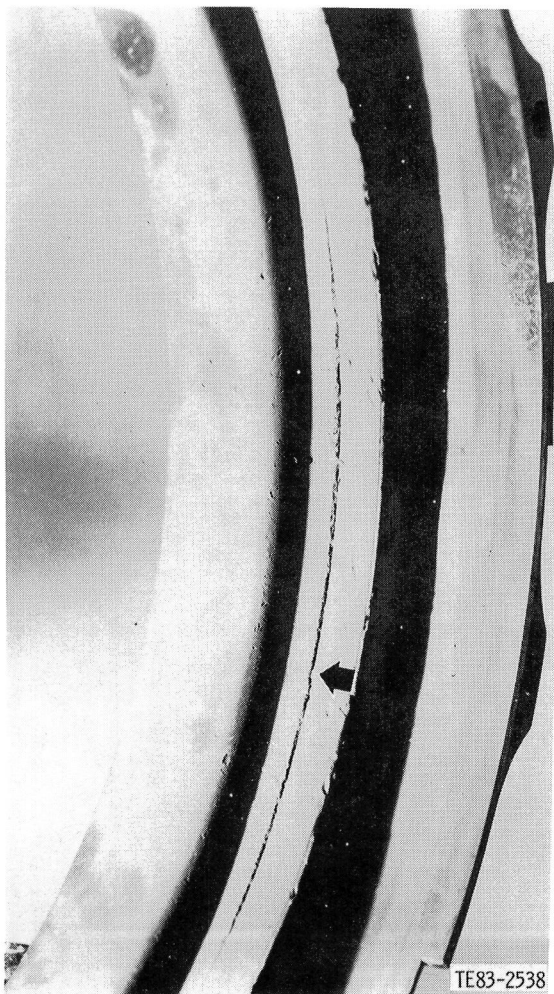
Figure 67. Crack in braze joint of shroud assembly.

A few identifiable pieces of the shroud ring were trapped in the power turbine inlet nozzle (see Figure 67). These pieces were sent to the materials lab for evaluation but a meaningful analysis was not possible. The abradable layer appeared to have been blasted by debris.

Postfailure investigation did reveal a concern for potential failure of the tip shroud from adverse thermal gradients (thermal stress). At teardown, a crack was observed in the metal gasifier turbine shroud assembly as illustrated in Figure 68. The crack in a braze joint, as in Figure 65, extended over a 70 deg arc (10 to 2 o'clock) centered on the burner. The concern was for strut cooling air bleeding through the crack and impinging on the outer diameter of the ceramic shroud ring, thus creating local thermal stresses. Analysis revealed the following:

- visual evidence of a difference in flow deposits (debris) in the area of the crack versus adjacent areas

- minimal potential for cooling air to flow through the crack, indicated by secondary flow calculations
- a minimum of oxidation in the failed braze joint, determined by metallurgical analysis
- poor wetting and flowing of the braze in the joint

As a result of all the evidence, thermal stress failure of the ceramic tip shroud is considered possible but not likely.

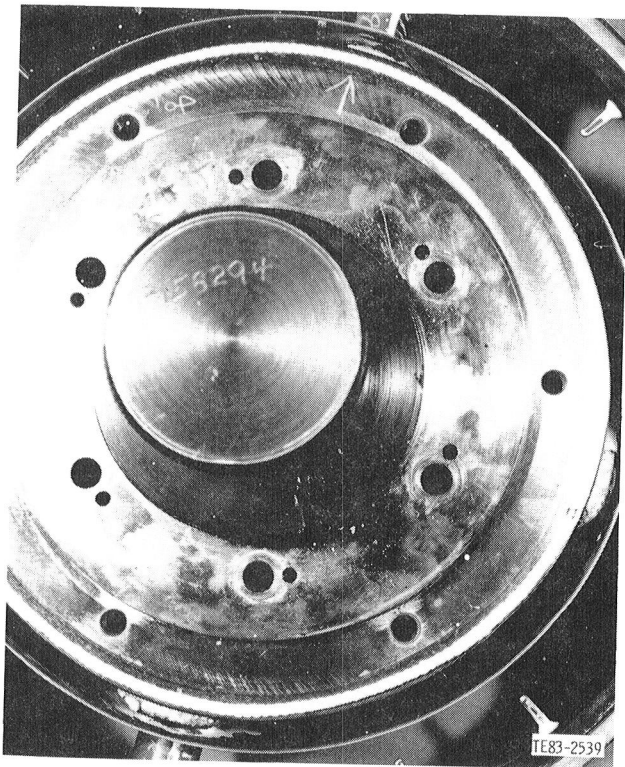
Figure 69. Missing H-cement around strut shells at the plenum inner annulus for engine C-4, TD14.

and instrumentation itself was also intact. However, pieces of H-cement (high temperature ceramic cement) around each of the strut shells and chips of zirconia plasma spray in the plenum gas flow path were missing. Figures 69, 70, and 71 show the area where the H-cement and zirconia plasma spray were missing. The sizes of these pieces can fit through the vane throat and could impact the gasifier turbine rotor. The pieces of H-cement located around the plenum strut shells ceramic rope packing seal could have either been ingested directly into the plenum or found their way into the combustor dilution holes (see Figure 72). It is also possible that the dislodging of these pieces could have occurred as a result of high vibration at the moment of failure.

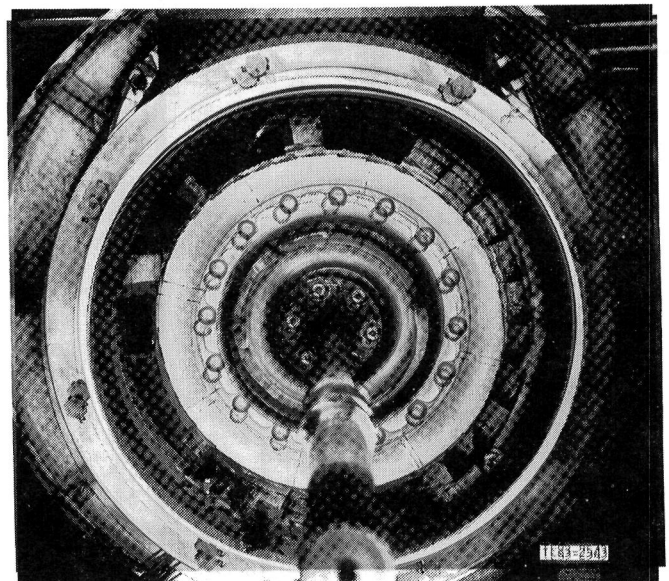
Figure 73. Gasifier turbine assembly for engine C-4, TD14 (overall view).

Upon removal of the gasifier nozzle assembly from the engine, some initial observations were made. Figures 73 and 74 show the gasifier section looking from the rear. Approximately half the nozzle section was missing and rotor airfoils were missing. No rub marks were seen on the outlet side of the gasifier turbine wheel.
